Manhole Inspection Summary

Manhole # S45C2_035MH

Location Address: **3706 Pennington Ave**

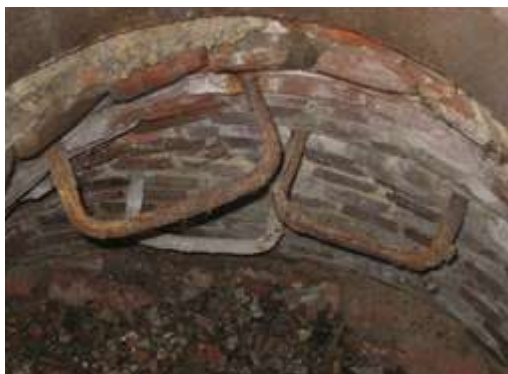
Steps

Count: **3** Missing: **0** ☒ **Corroded**

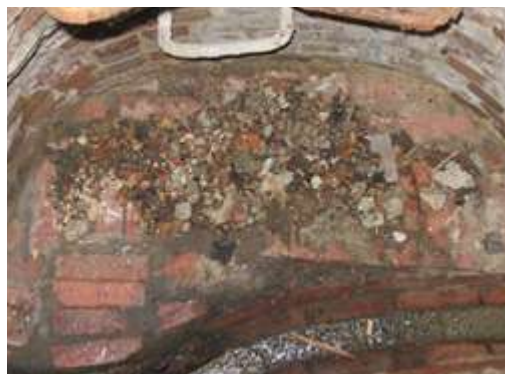
Defect 2

Debris

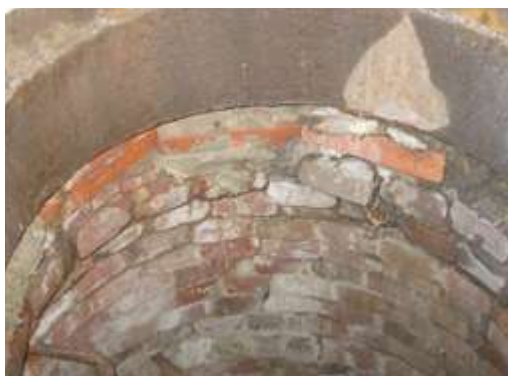
Defect 1

Condition: ☐ Sound ☐ Cracked ☐ Root Intrusion ☒ **Loose Brick** ☐ Deteriorated

Infiltration: ☐ None ☐ Joint ☐ Cracks ☒ **Mortar** ☐ Roots ☐ Wall

Infiltration

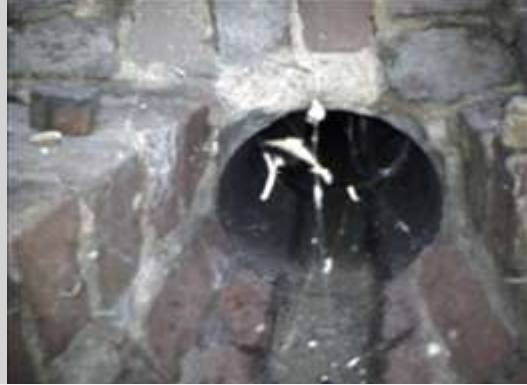
12 O'Clock Outflow

8 in. Circular Gravity Sewer
Pipe Out @ 12 O'Clock

Pipe Material: **DIP/CI** ☐ Pipe Lined

Infiltration: **None** Pipe Seal Cond: **Sound**

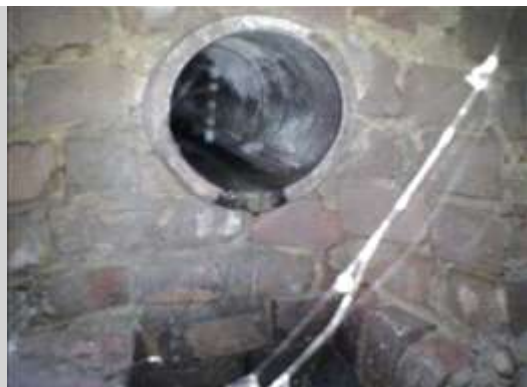
5 O'Clock Inflow

6 in. Circular Service Sewer
Pipe In @ 5 O'Clock

Pipe Material: **Clay** ☐ Pipe Lined

Infiltration: **None** Pipe Seal Cond: **Sound**

Drop: **Outside Direct**

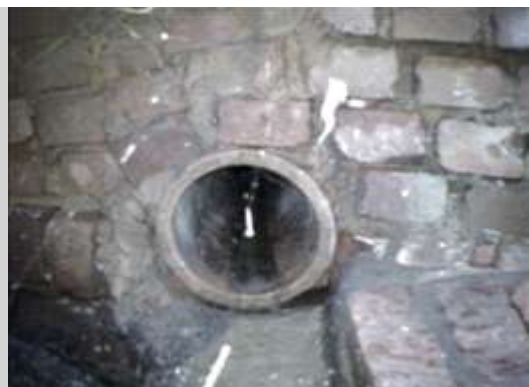
6 O'Clock Inflow

6 in. Circular Service Sewer
Pipe In @ 6 O'Clock

Pipe Material: **Clay** ☐ Pipe Lined

Infiltration: **None**

Pipe Seal Cond: **Sound**
